# Pressure Relief Drainage

Groundwater drainage and leak detection beneath snow pond, Pozidrain, San Martino di Castrozza[TN], Italy

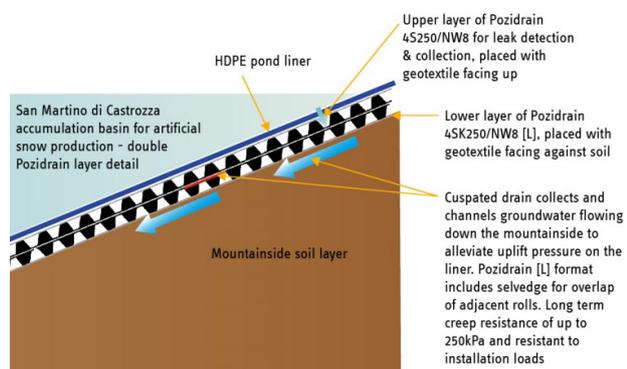
**Dual layer of Pozidrain 4SK250/NW8 installed back-to-back to provide groundwater drainage & leak detection functions**

placed directly underneath the liner, back-to-back with the first, to provide a leakage collection, drainage and monitoring layer. The double layer was only required on the slopes facing the mountainside for groundwater pressure relief (see function diagram on the right). On the valley side, a single layer for leakage collection was installed.

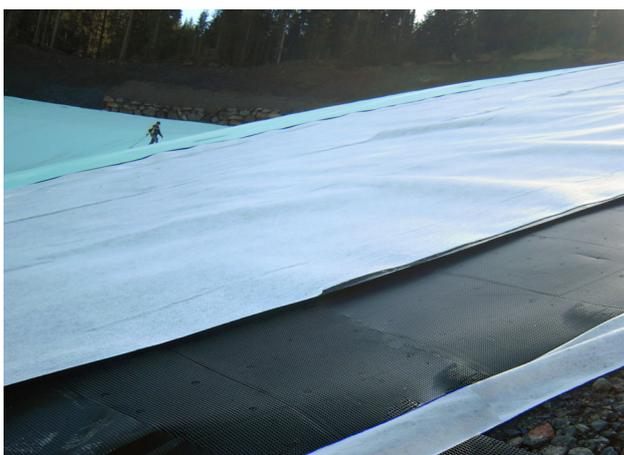
First layer in the foreground with geotextile face down for groundwater pressure relief and second layer with geotextile facing upwards for liner leak detection / collection

**Pozidrain 4SK250/NW8 [L]** was laid textile to soil as a groundwater drainage layer. It was chosen to provide a thin and effective water pressure relief membrane, having a flow capacity sufficient to cope with the groundwater conditions expected locally. This version of **Pozidrain** was also selected for both its long term creep resistance of up to 250kPa and for resistance to installation loads. The addition of an “L” flat selvedge down one edge of the **Pozidrain 4SK250/NW8 [L]** rolls enabled a pressure seal between adjacent rolls which assist in preventing leakage from the pond if the liner is damaged. A second layer with textile facing upwards was
