Airport Taxiway Rehabilitation

Asphalt Reinforcement, Heathrow Airport, UK

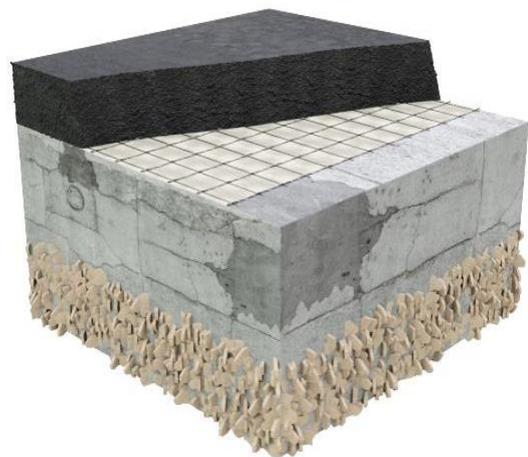
High-strength, low-strain reinforcement interlayer

The ABG range of asphalt reinforcement products provide a low strain composite layer combining a non-woven polyester geotextile and glass fibre or steel grid. Benefits include a substantial reduction in the asphalt overlay thickness required and a significant extension of the pavement service life, reducing associated maintenance periods and costs as a result.

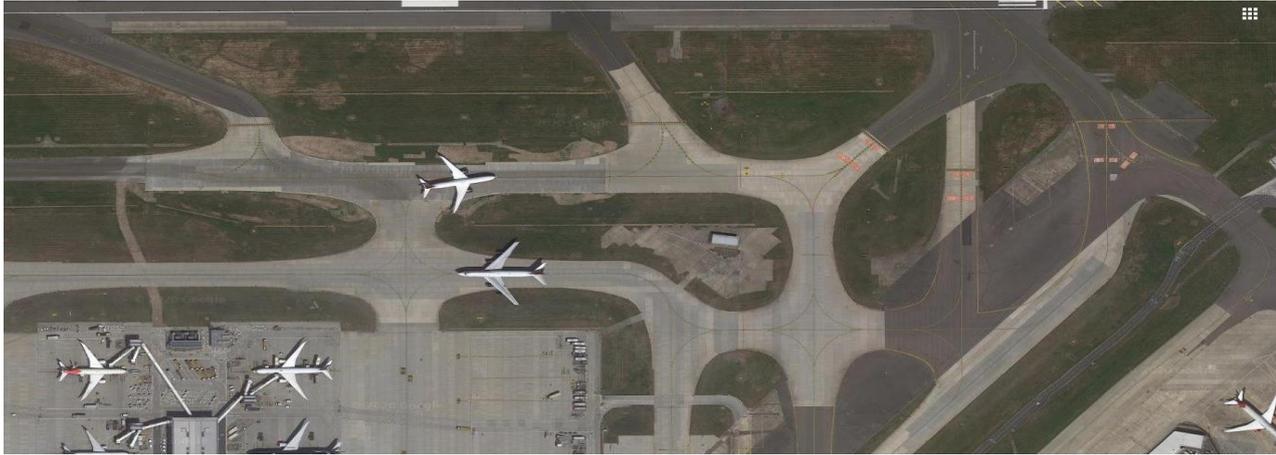
Following pre-patching and joint-sealing, 6,400 m² of asphalt reinforcement grid was supplied and installed by ABG Ltd on Taxiway Blocks 118/119. The ABG reinforcement layer was installed directly on the existing surface and immediately overlaid with a 50mm proprietary surfacing material. Disruption to air traffic was minimised by working under night-time closures over 2 shifts.

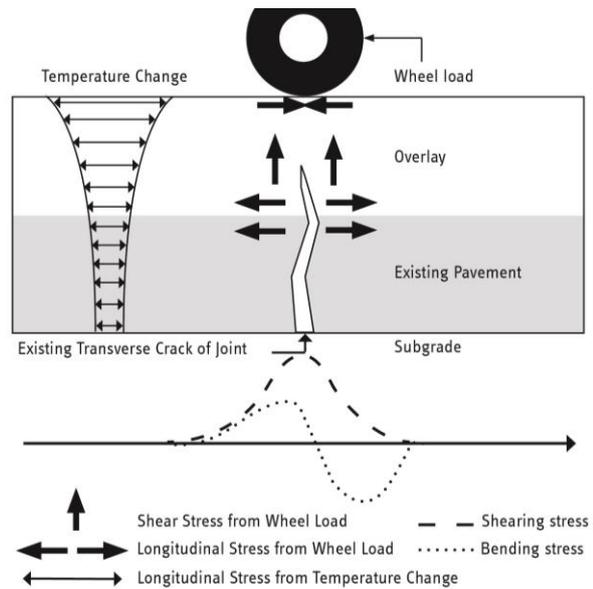
Mechanism of Reflective Cracking

Damage arising from reflective cracking means increased maintenance disruption and costs. A cost-effective method for controlling reflective cracking and further deformation of the pavement was therefore required.

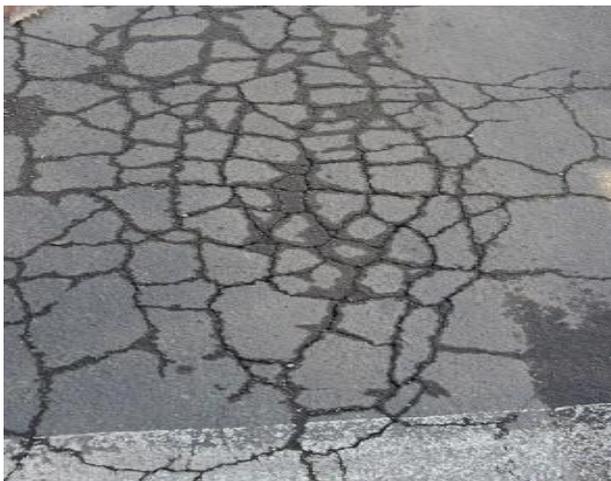
Solution to reflective cracking

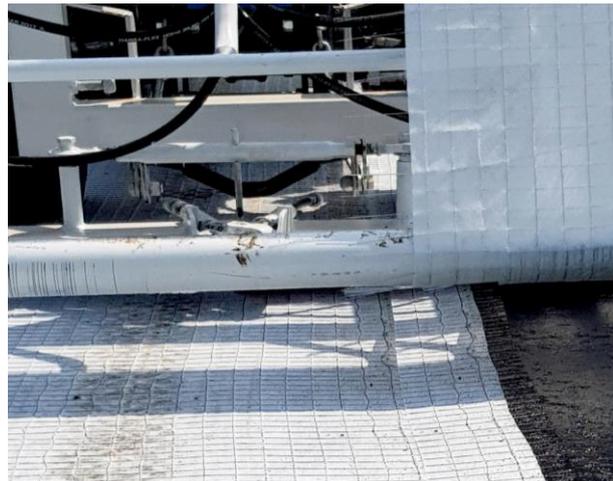
Quick to install and bond, with reduced overlay required
