# Contaminated Land

Capillary Break, Pozibreak, Vane Tempest, Seaham, UK

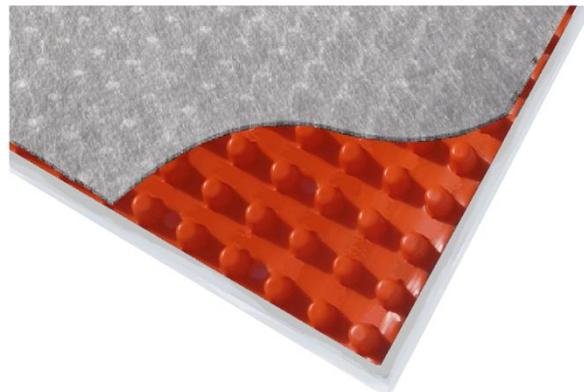
**ABG Pozibreak Capillary Break Layer  
placed geotextile down**

**ABG** proposed **Pozibreak** geocomposite capillary break layer in lieu of the 250mm layer of 6F2 stone. **Pozibreak** was manufactured coloured bright orange ; this removed the need for an additional indicator geogrid. The specified **Pozibreak** was manufactured from HDPE, which provided excellent resistance to the chemicals present in the contaminated ground. By choosing **Pozibreak** the client and contractor were able to reduce the number of vehicle movements by 2,500, greatly minimising the environmental impact on Seaham and vastly speeding up the construction.

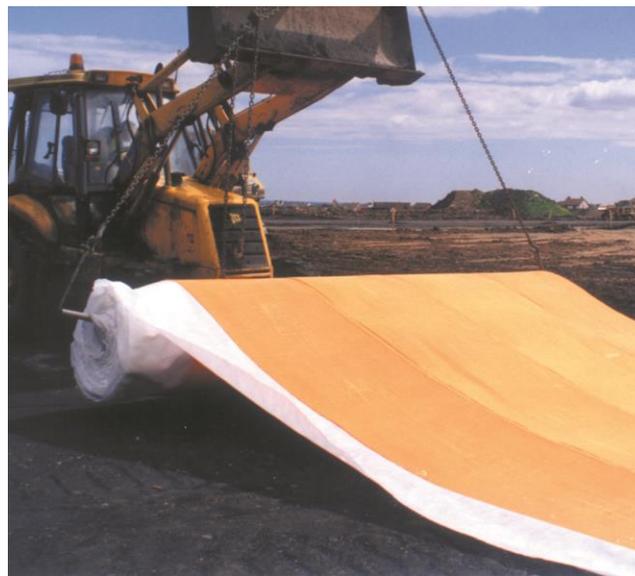
**Pozibreak being installed in 4.4m wide rolls**

**Pozibreak** was supplied in rolls 4.4m wide and 50m long with the upper side virtually impermeable to water. This served to create an additional partial capping layer that also prevented the clay layer from drying out and cracking.

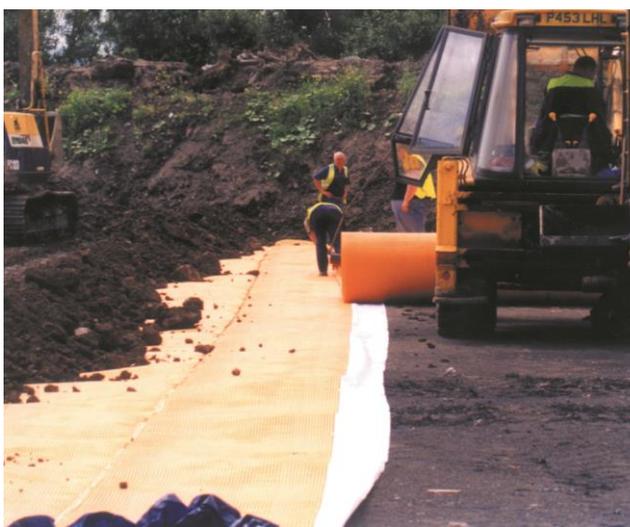
**Overlapping Pozibreak rolls to form a continuous layer**

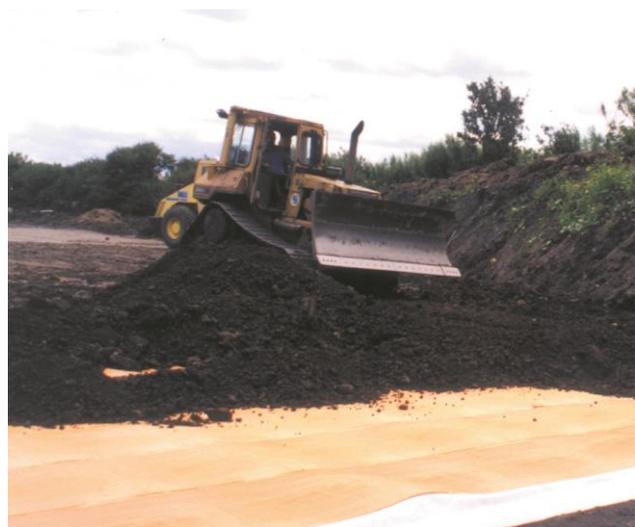
**Clay layer placed on Pozibreak**
