Structural Drainage

Reservoir Roof, Deckdrain G, Cross Hill, Barnston, Wirral, UK

Project Description

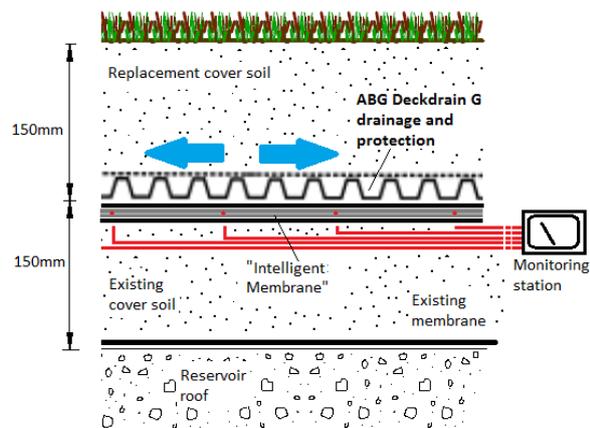
High flow ABG Deckdrain protects and prevents ponding complementing the "Intelligent Membrane" system

Firstly only 150mm of the 300mm depth of cover soil was removed by hand and the remaining soil was levelled reducing the time taken and avoiding damaging the existing reservoir roof surface. A new Sensor Detection System ("Intelligent Membrane") was placed and protected by **ABG Deckdrain G** multiple direction drainage geocomposite. This replaces the costly and commonly used drainage stone. The old structure needs careful monitoring and the new aerial leak detection system constantly monitors for potential leaks allowing rapid localised remedial action should a leak occur. To reduce the chance of ponding, the lightweight, high flow, **Deckdrain G** overlays the membrane and drains standing water away whilst protecting the membrane from the cover soil and light trafficking. **Deckdrain G** geocomposite is fully compatible with the "Intelligent Membrane" and this ensured rapid installation on this very restricted site.

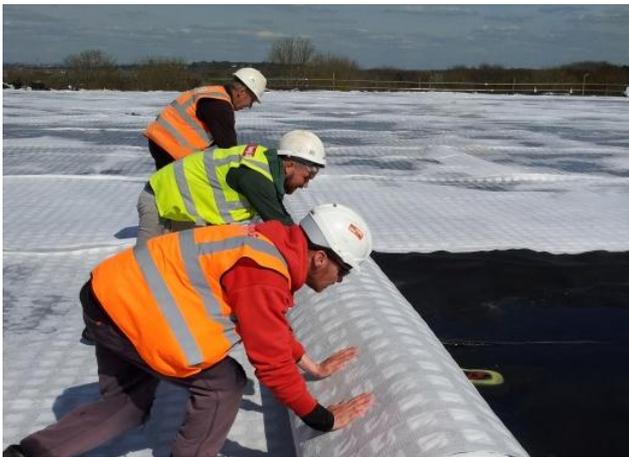
Installing Deckdrain over membrane

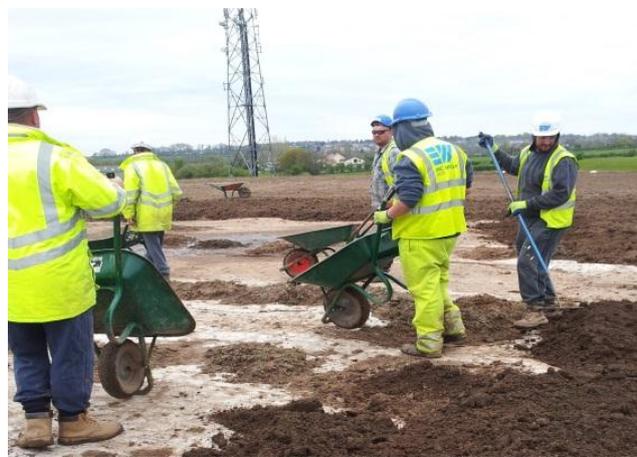
Backfill by hand prior to seeding and completion
